Industrial Bus Health testing with Fluke 125 Industrial ScopeMeter®

Application Note

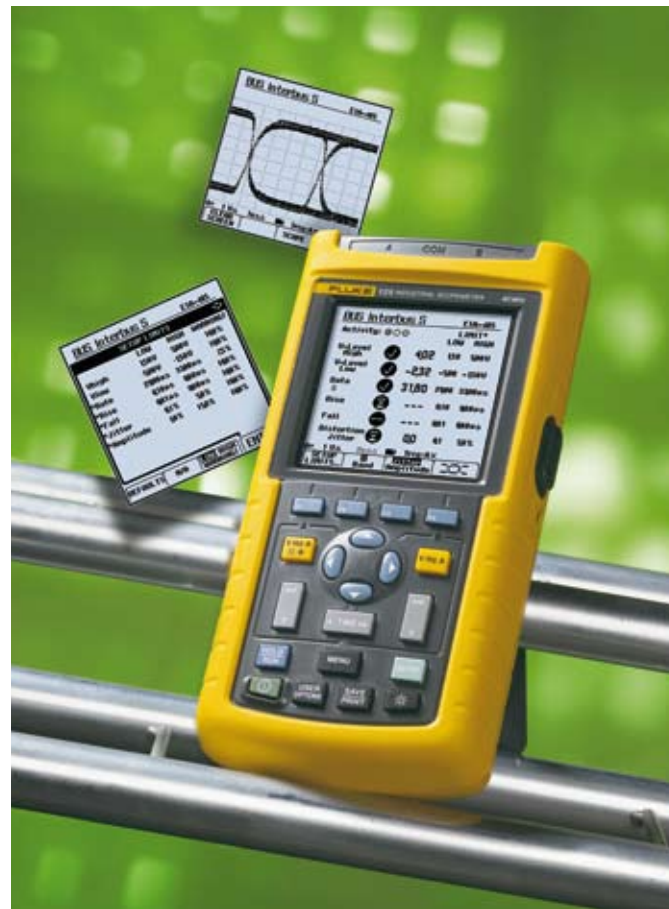
which may induce considerable noise on the bus wiring.

A health check on the RS-485 bus communicating between the control unit and the motor drive immediately revealed that the signal did not comply with the standards for the bus. Specifically, there was far too much noise on the bus with the V-level, jitter and overshoot all showing a "not OK" warning on the display, indicating that they were outside specifications. Signal integrity near the motor drive at the top of the elevator shaft was also checked using the ScopeMeter with

Based on the findings, the Woonstede service engineers carried out a further investigation of the hardware in this section of the bus system and found:

- the routing of the bus cable was close to the power line which is a known source of EM interference
- the bus cabling did not comply with the recommendations of the elevator manufacturer who had specified shielded cable to minimize EM interference

The bus cable was therefore replaced by shielded cable and was re-routed away from the power line.

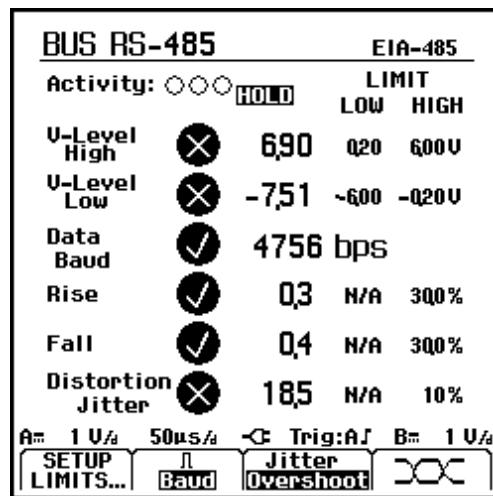
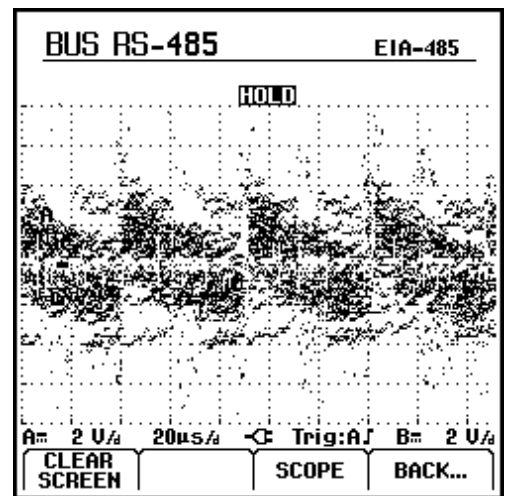
the same result, i.e. there was far too much noise on the bus.

Figure 1 Left: The V-level jitter and overshoot readings were all out of specification for the bus. Right: The alternative way of looking at the bus signals using the eye-pattern mode shows a lot of noise on the bus, indicating an aberration on the signal at this location.
