Finding a Power Quality needle

In a 30-mile haystack

Power Quality **Case Study**

Inspections: Power quality/harmonics logging at site, voltage distortion at multiple feeder lines

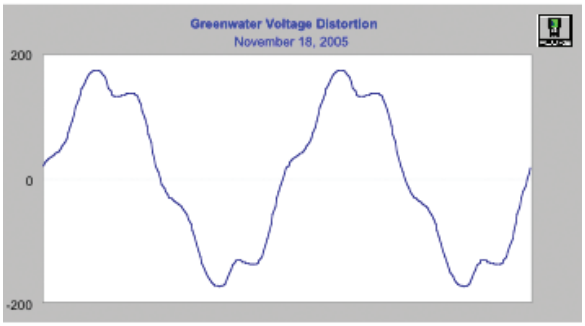
On the way up to the ski area, DeCrausaz took a measurement with a Fluke 41B power meter at an outside receptacle of a convenience store in Greenwater. Greenwater is a bedroom community on the main power line feed from Enumclaw to Crystal Mountain. The voltage distortion was huge at 14 % shown below.

Greenwater convenience store 120 vac receptacle.
All lifts at Crystal Mountain running. Filters off.

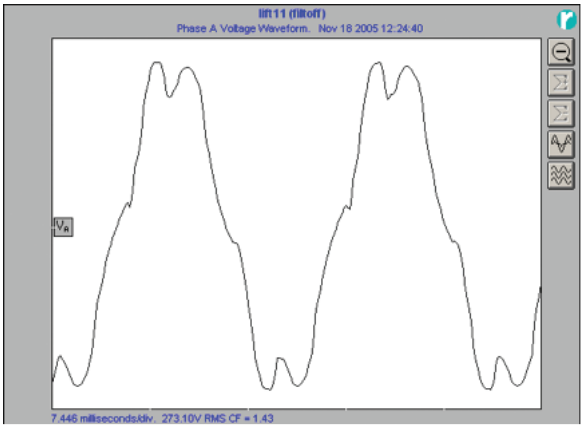
When first on-site, DeCrausaz and McConnell made an attempt to measure the voltage and current of the problem power filters with the lifts running, it turned out this was impossible due to the possibility of damaging the filter. The filter would have to absorb the entire harmonic current of the utility system plus the harmonic current generated by the dc drive of the lift. Note below the voltage waveform at Lift 11 with all the lifts running and NO filters on line.

Lift 11 with all lifts running and no filters on line.

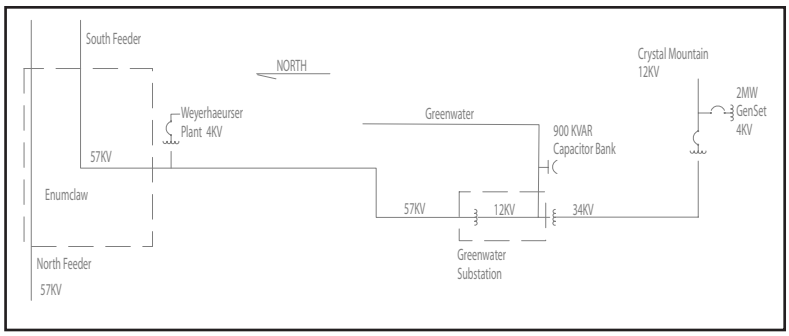
After further investigation, a 900 kvar-capacitor bank was located on a pole near the Greenwater substation on the 12 kv line servicing the town. The capacitors had been switched online at the end of April for a still undetermined reason. During the summer the C-phase fuse had blown several times and been replaced. The C-phase fuse was out and hanging down when the capacitor bank was located. At that point, the utility removed the remaining two fuses and said it planned to remove the capacitor bank from the pole so that it couldn't be inadvertently energized.

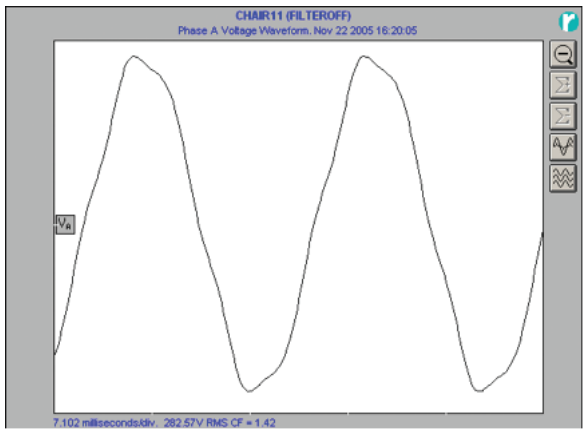
Later at the ski area, the following voltage waveform was recorded at Lift 11 with the mountain shutdown for the evening. Note the amount of distortion still on the utility system.

Lift 11 off. Filter off. All other lifts off. Utility caps off.

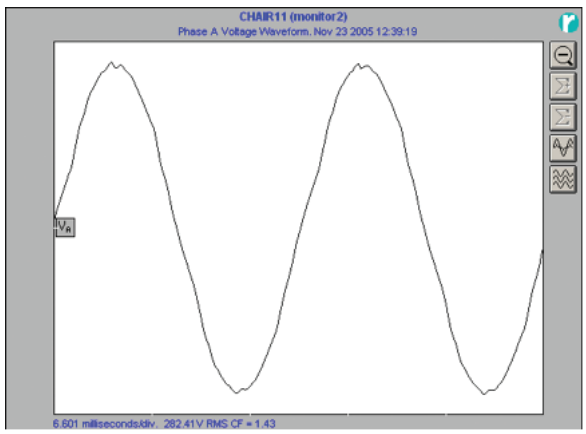
That evening at the ski area, all the power filters were put on-line and measurements taken to prove their health. The voltage distortion at the area was reduced to 3.1 % THD. The next day, technicians turned on all of the lifts with all four filters and all of the pumping stations and conveyors online. The voltage waveform below is at Lift 11 with all the lifts and filters on line.

Lift 11 on, filter-3 steps. Lift 10 on, filter-3 steps. Lift 9 on, filter-3 steps. Lift 3 on, filter-2 steps. All other lifts running.
